NEW DRESSER NO. 4 DAM  
WASHINGTON COUNTY, MISSOURI  
MO 31124

**PHASE I INSPECTION REPORT  
NATIONAL DAM SAFETY PROGRAM**

NEW DRESSER NO. 4 DAM  
WASHINGTON COUNTY, MISSOURI

PREPARED BY  
INTERNATIONAL ENGINEERING COMPANY, INC.  
CONSULTING ENGINEERS  
SAN FRANCISCO, CALIFORNIA

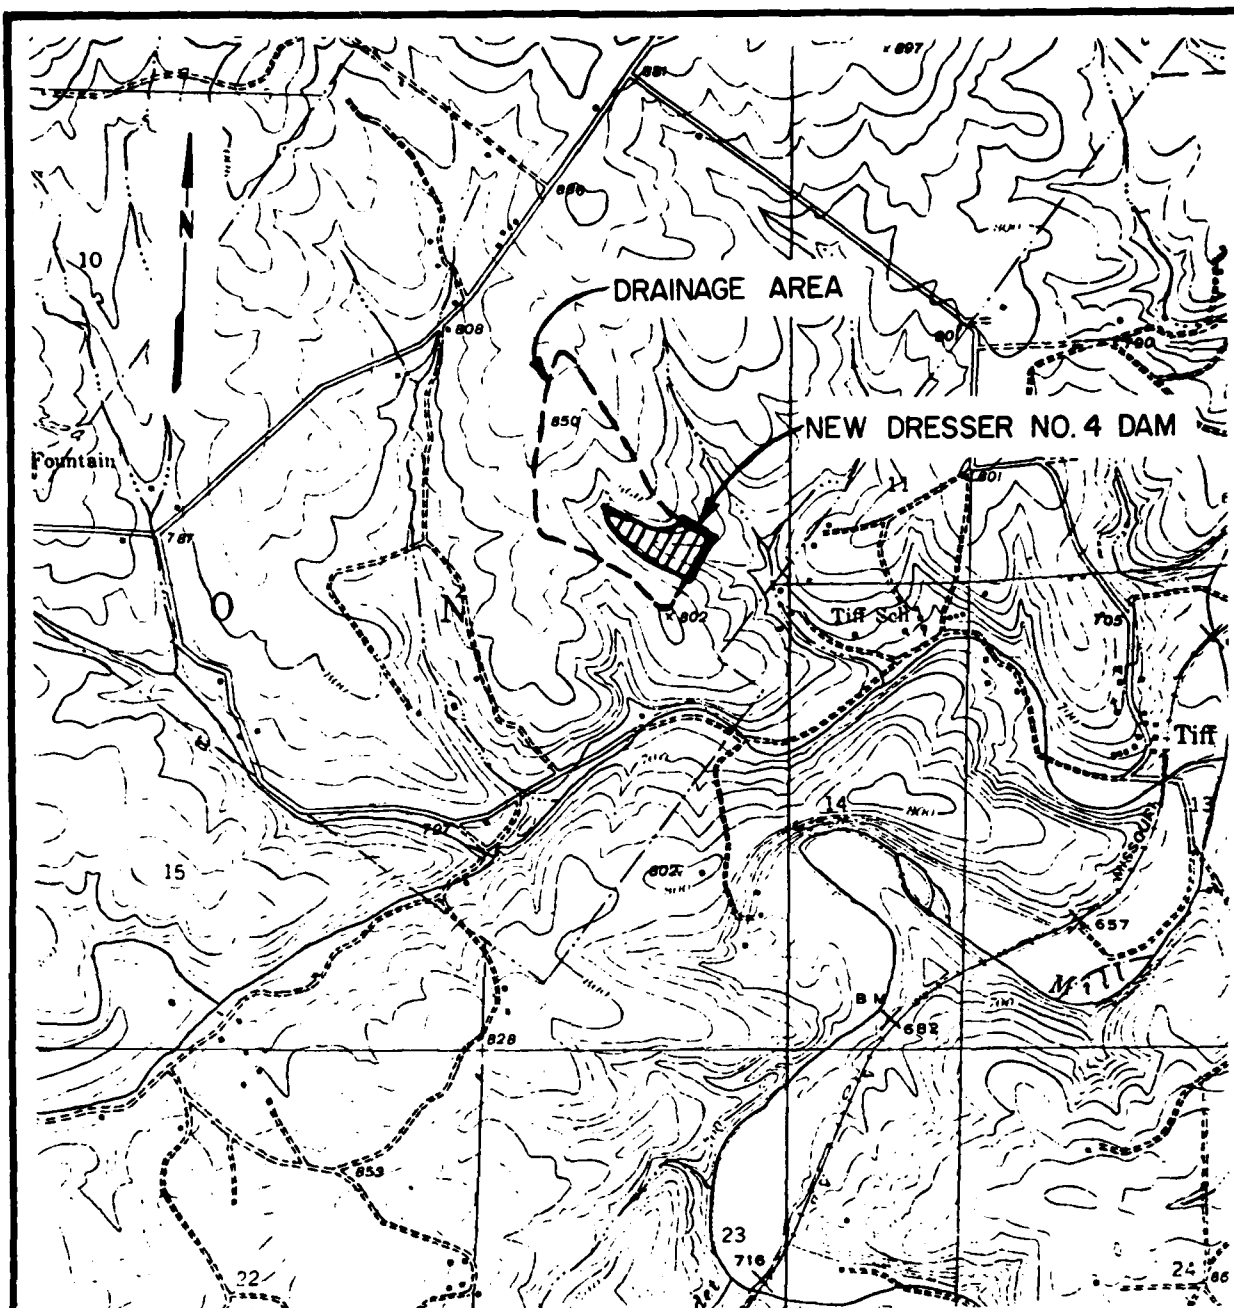
PLATE 2

The drainage area, as shown on Plate 2, is about 62 acres (0.1-square mile). Land use and vegetation patterns in the watershed were determined from field observations and aerial photographs of the project area, and are divided into the following categories:
